Appendix 3

Resistograph Readings

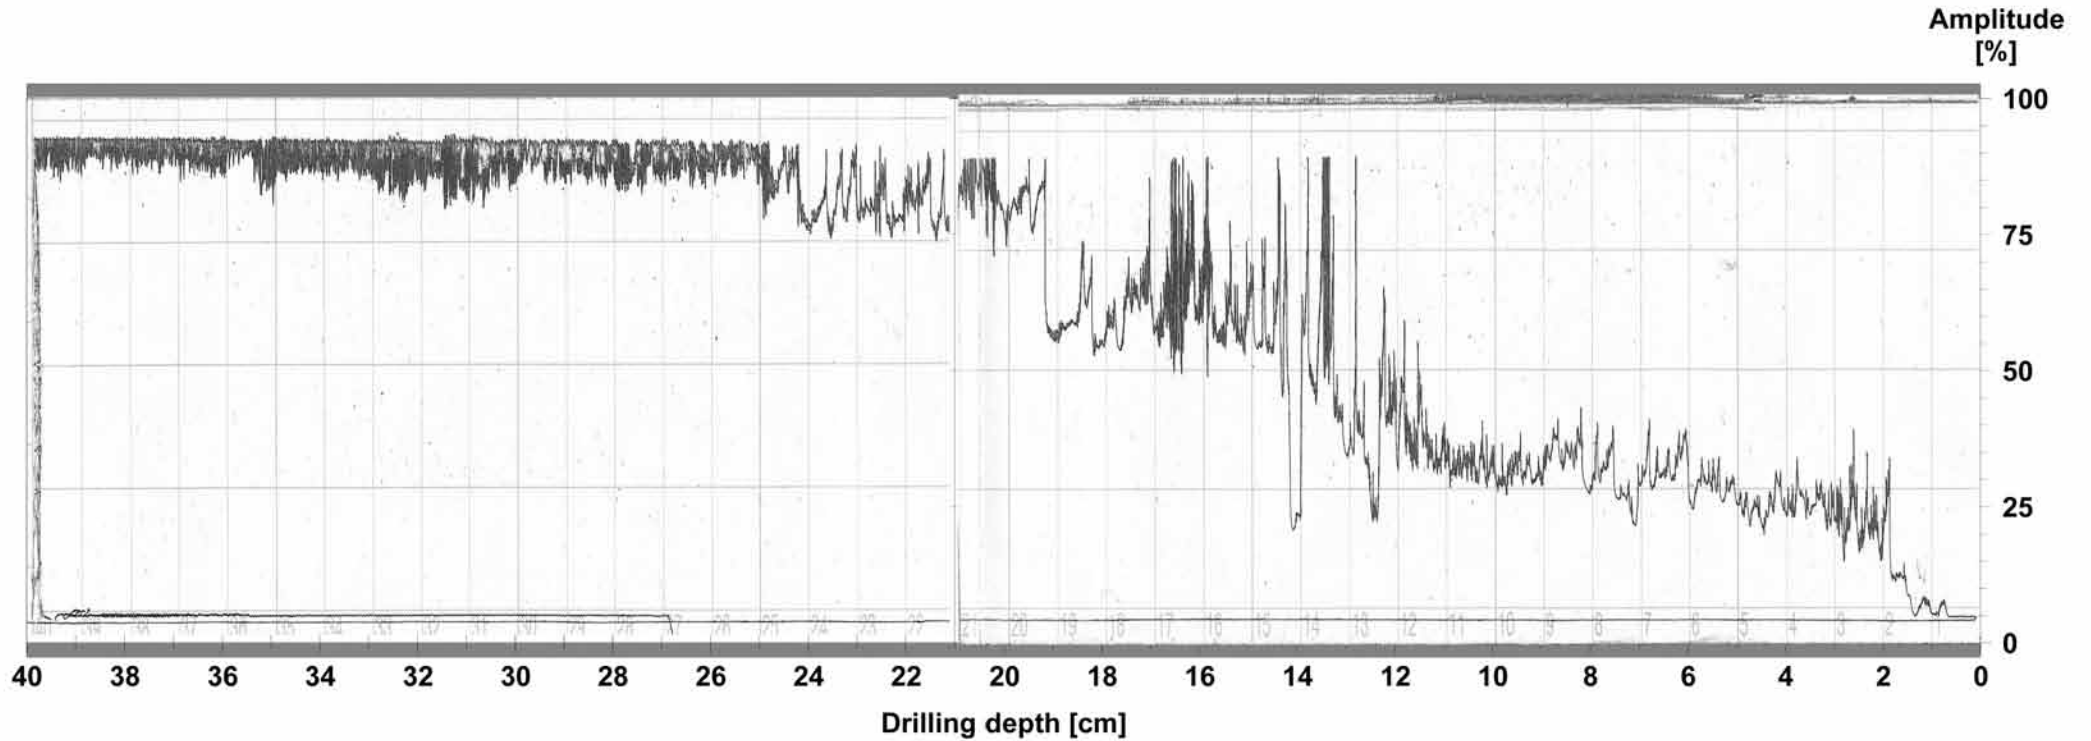
■	From 0,0 cm to 40,0 cm : Normal
□	From 0,0 cm to 0,0 cm :
□	From 0,0 cm to 0,0 cm :
□	From 0,0 cm to 0,0 cm :
□	From 0,0 cm to 0,0 cm :
□	From 0,0 cm to 0,0 cm :

There is no evidence that structural integrity has been compromised.

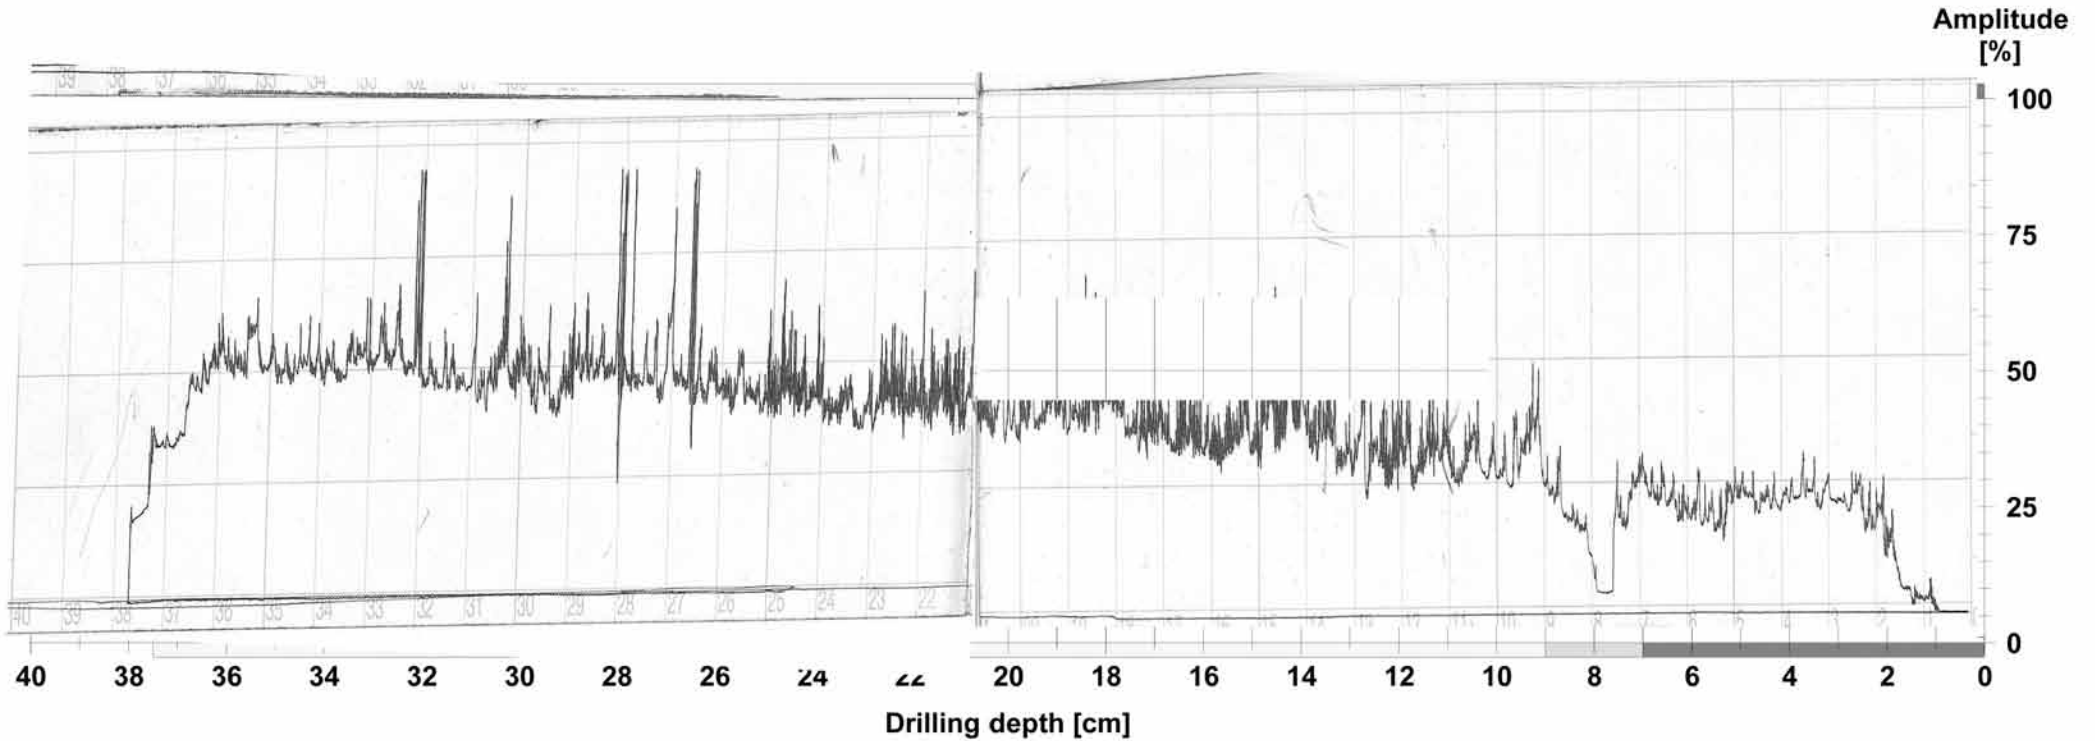
■	From 0,0 cm to 7,0 cm : Normal
■	From 7,0 cm to 9,0 cm : Dysfunctional wood
□	From 9,0 cm to 37,5 cm : Normal
□	From 0,0 cm to 0,0 cm :
□	From 0,0 cm to 0,0 cm :
□	From 0,0 cm to 0,0 cm :

There is small area of dysfunctional wood however this is not sufficient to compromise the structural integrity of the tree.

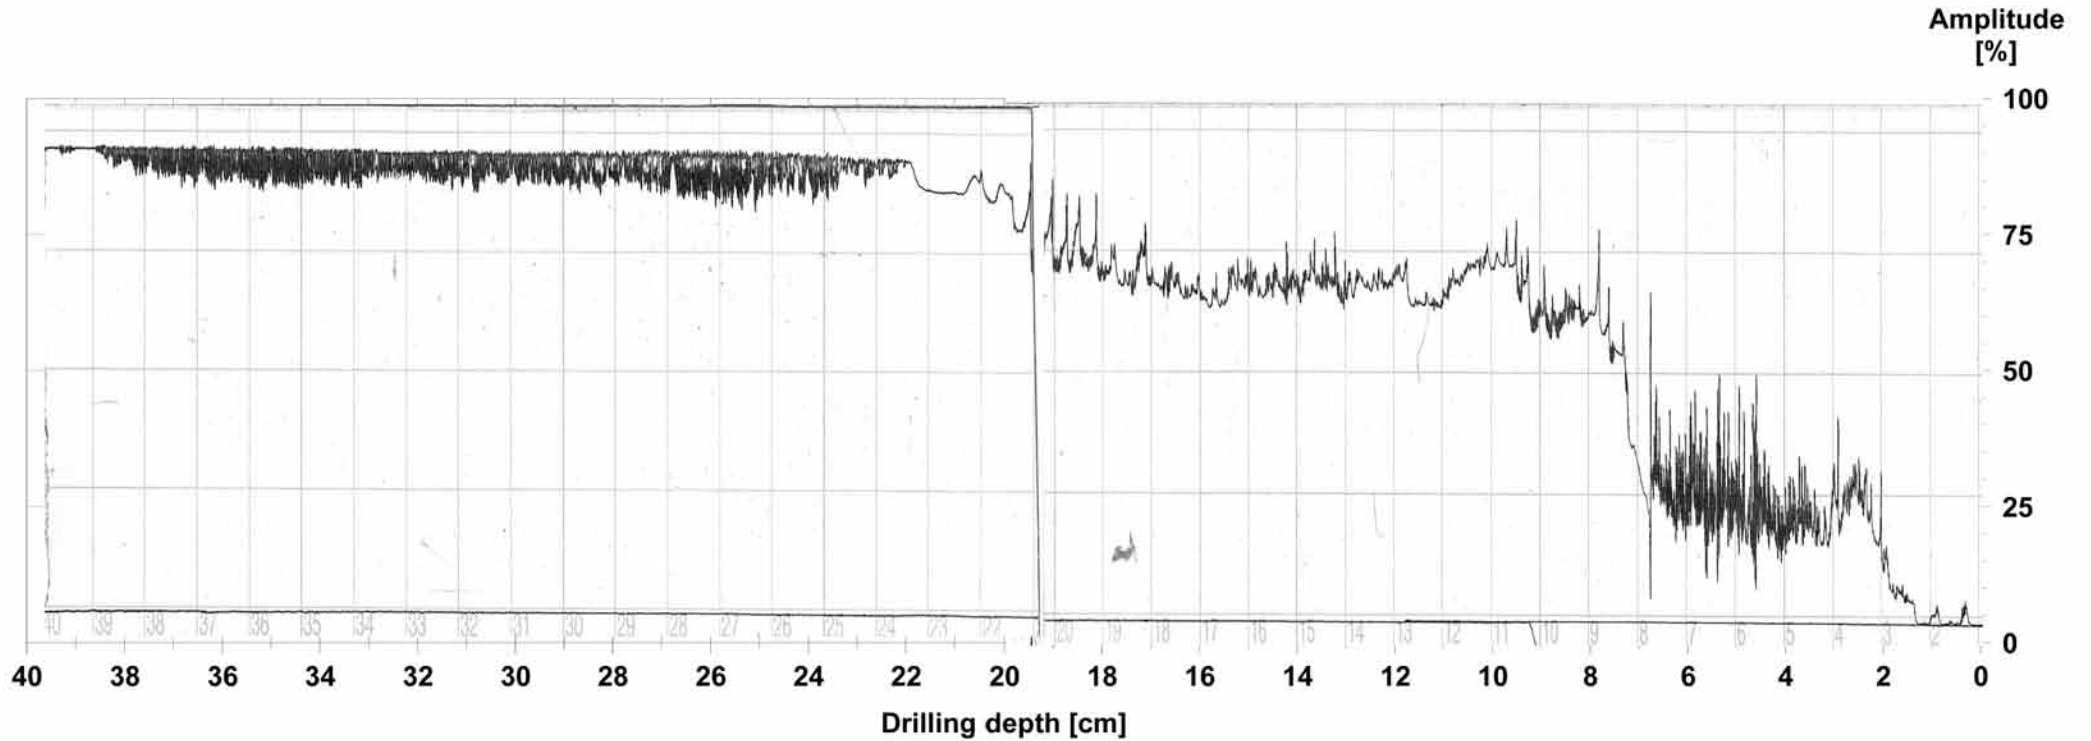
There is small area of dysfunctional wood however this is not sufficient to compromise the structural integrity of the tree.

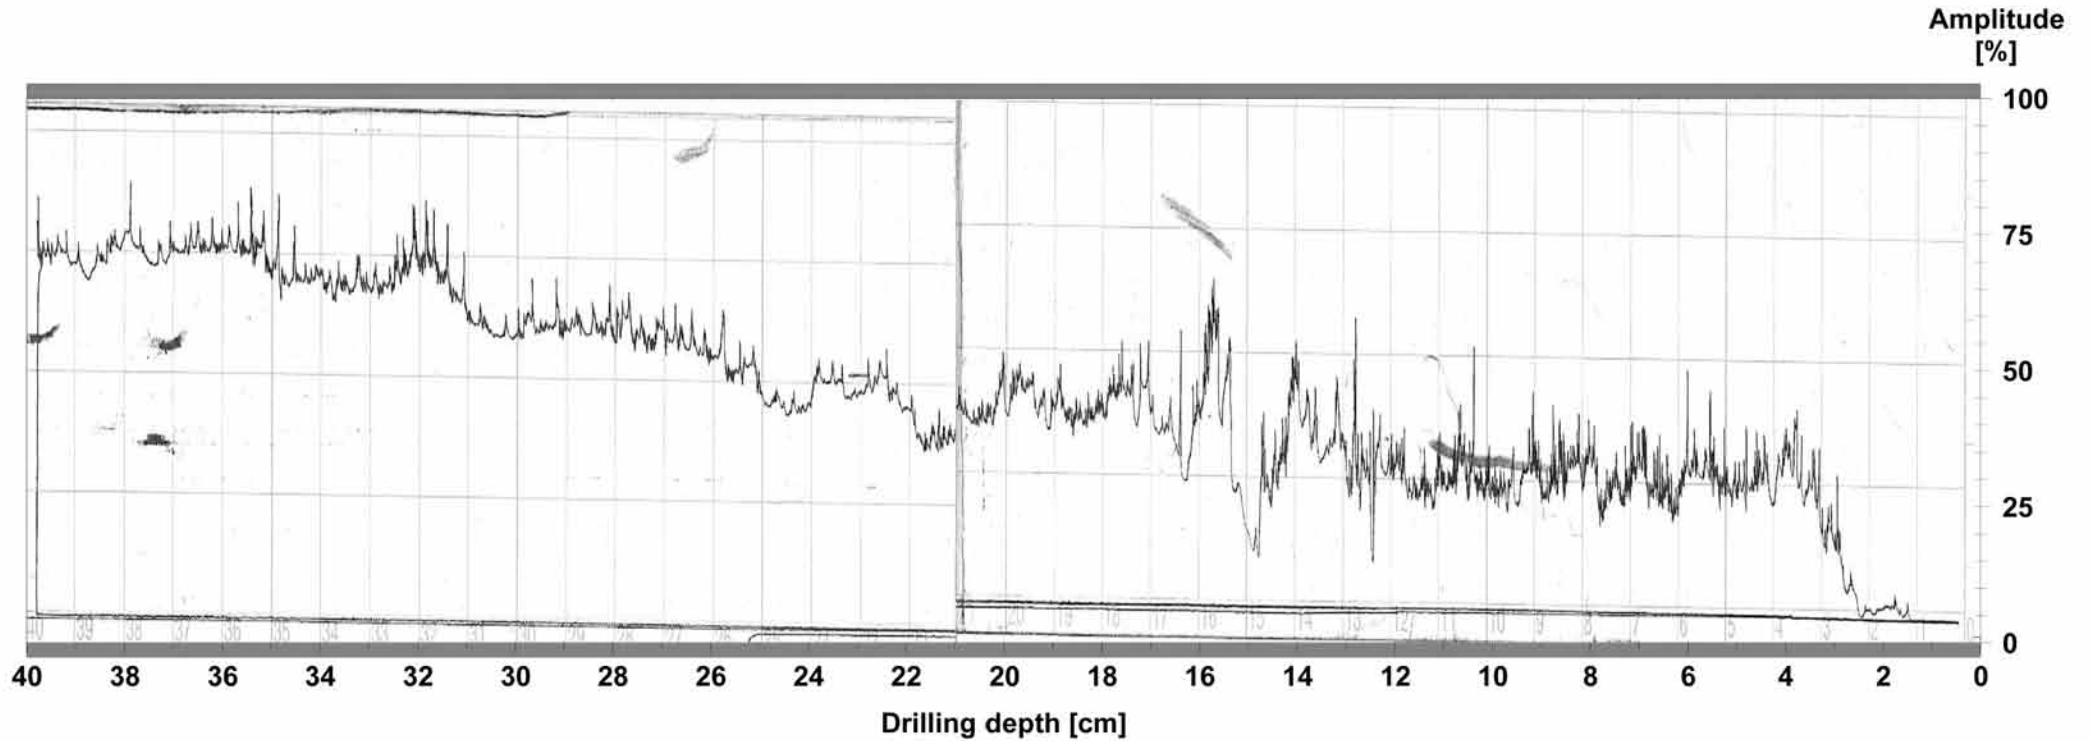
■	From 0,0 cm to 40,0 cm : Normal
□	From 0,0 cm to 0,0 cm :
□	From 0,0 cm to 0,0 cm :
□	From 0,0 cm to 0,0 cm :
□	From 0,0 cm to 0,0 cm :
□	From 0,0 cm to 0,0 cm :

There is no evidence that structural integrity has been compromised.

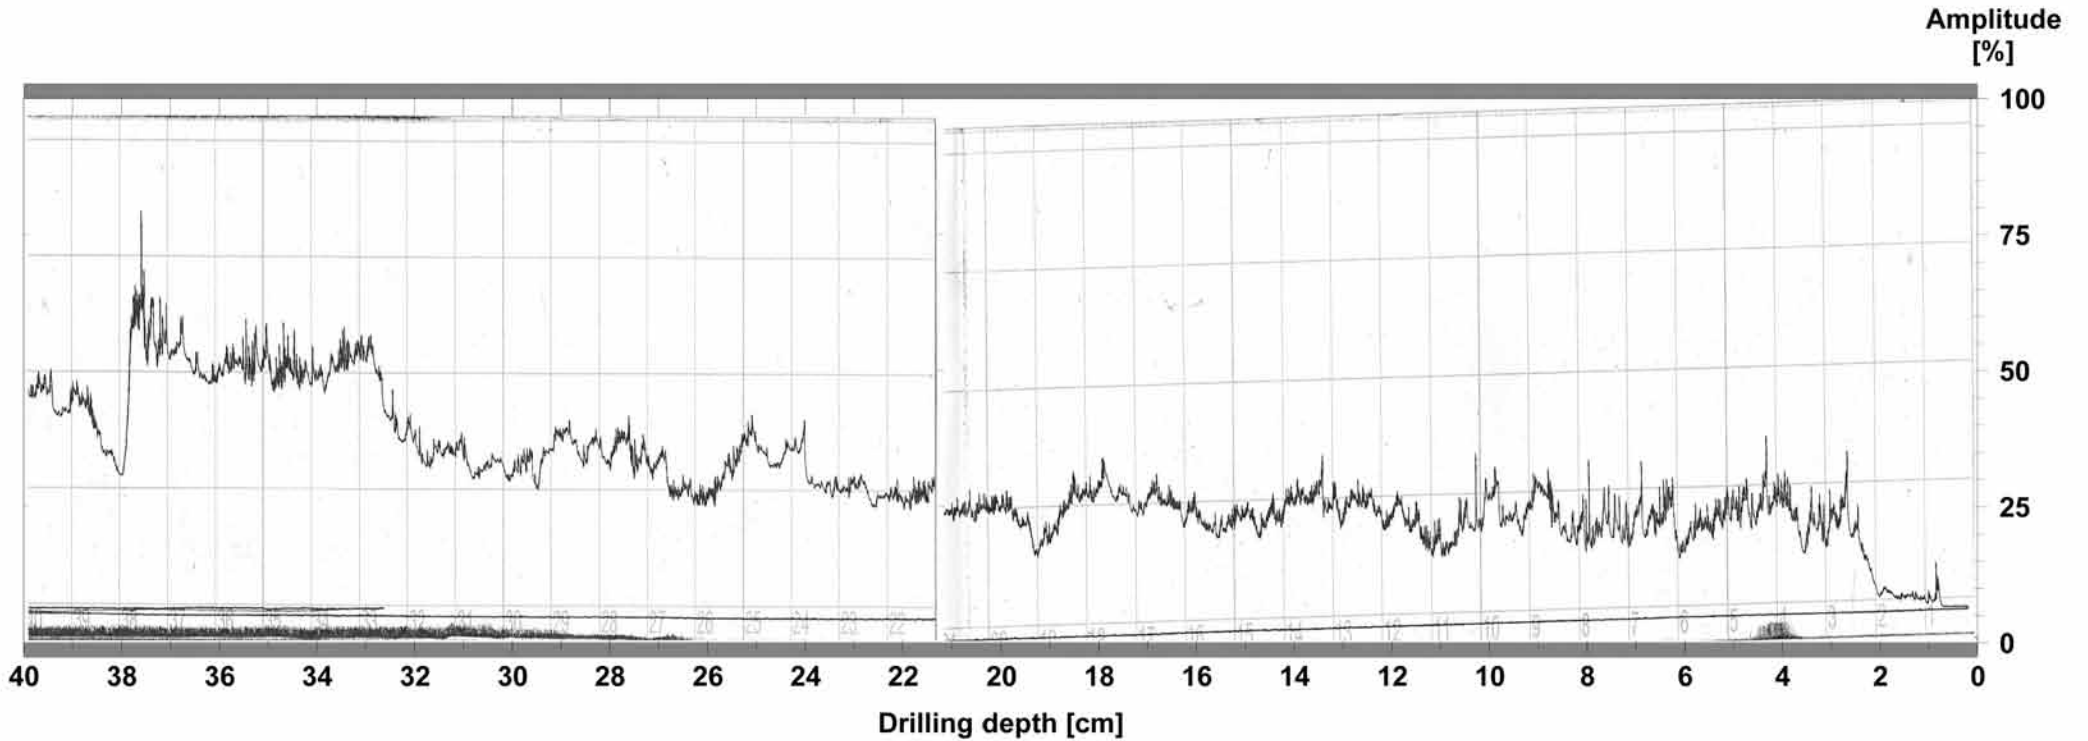
■	From 0,0 cm to 40,0 cm : Normal
□	From 0,0 cm to 0,0 cm :
□	From 0,0 cm to 0,0 cm :
□	From 0,0 cm to 0,0 cm :
□	From 0,0 cm to 0,0 cm :
□	From 0,0 cm to 0,0 cm :

There is no evidence that structural integrity has been compromised.

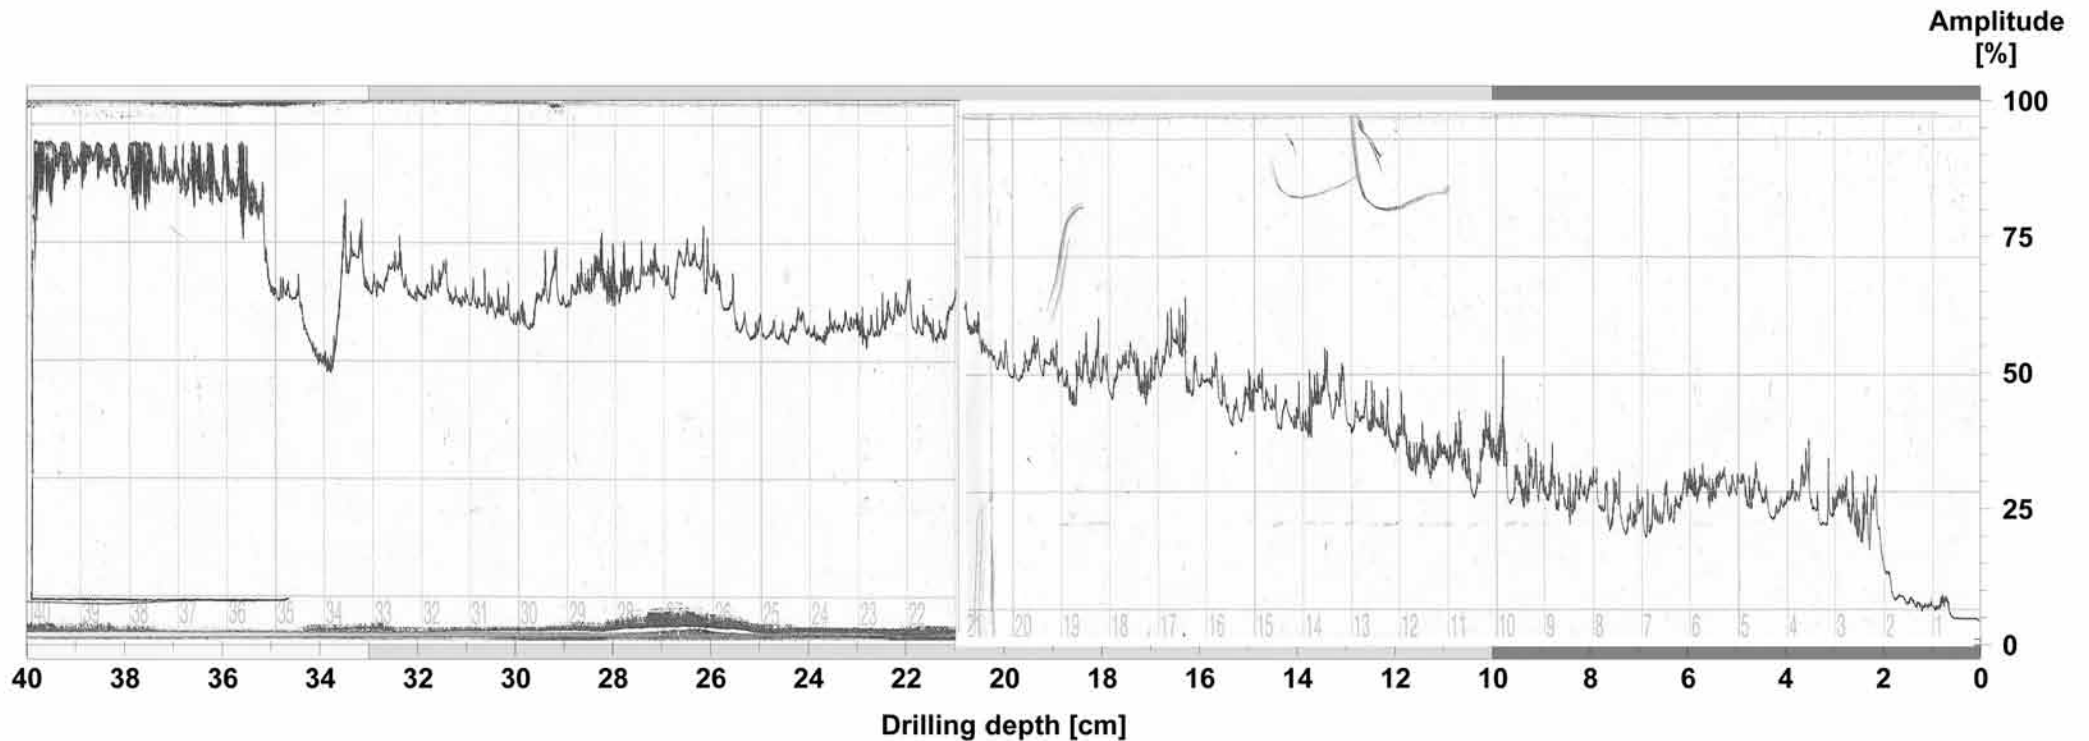
■	From	0,0 cm	to	10,0 cm	:	Normal
■	From	10,0 cm	to	33,0 cm	:	Dysfunctional
■	From	33,0 cm	to	40,0 cm	:	Normal
□	From	0,0 cm	to	0,0 cm	:	
□	From	0,0 cm	to	0,0 cm	:	
□	From	0,0 cm	to	0,0 cm	:

There is a partially dysfunctional (softer) core to the tree. At this stage it does not compromise the structural integrity of the tree to such an extent that removal is required however ongoing monitoring is essential.

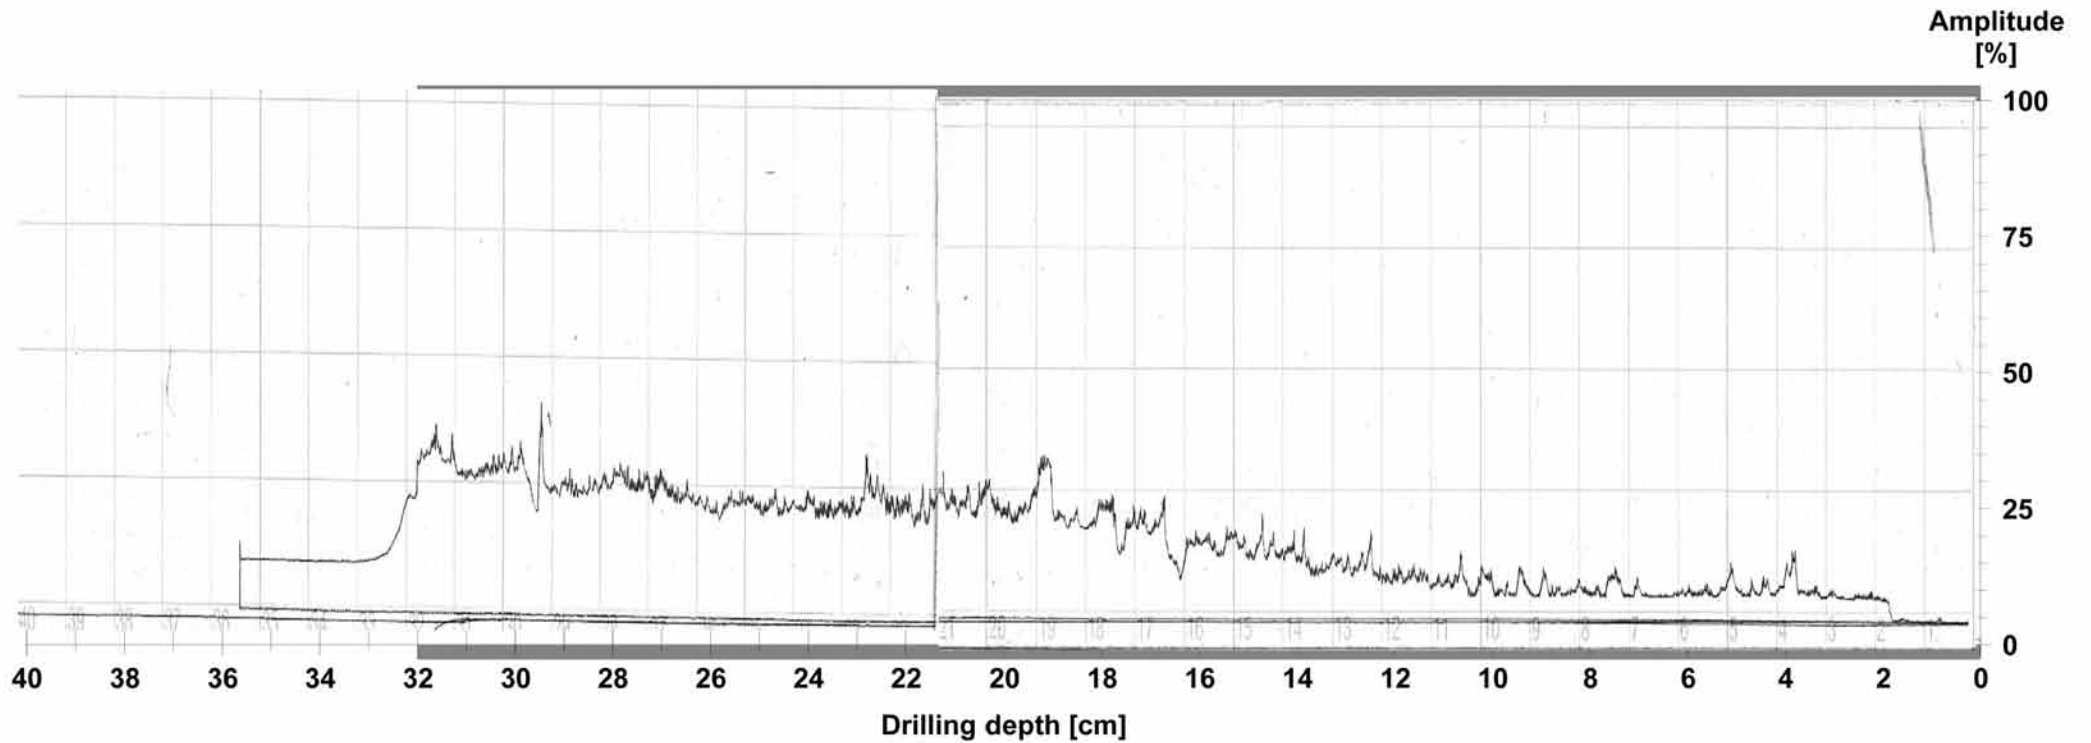
■	From 0,0 cm to 32,0 cm : Normal
□	From 0,0 cm to 0,0 cm :
□	From 0,0 cm to 0,0 cm :
□	From 0,0 cm to 0,0 cm :
□	From 0,0 cm to 0,0 cm :
□	From 0,0 cm to 0,0 cm :

There is no evidence that structural integrity has been compromised.

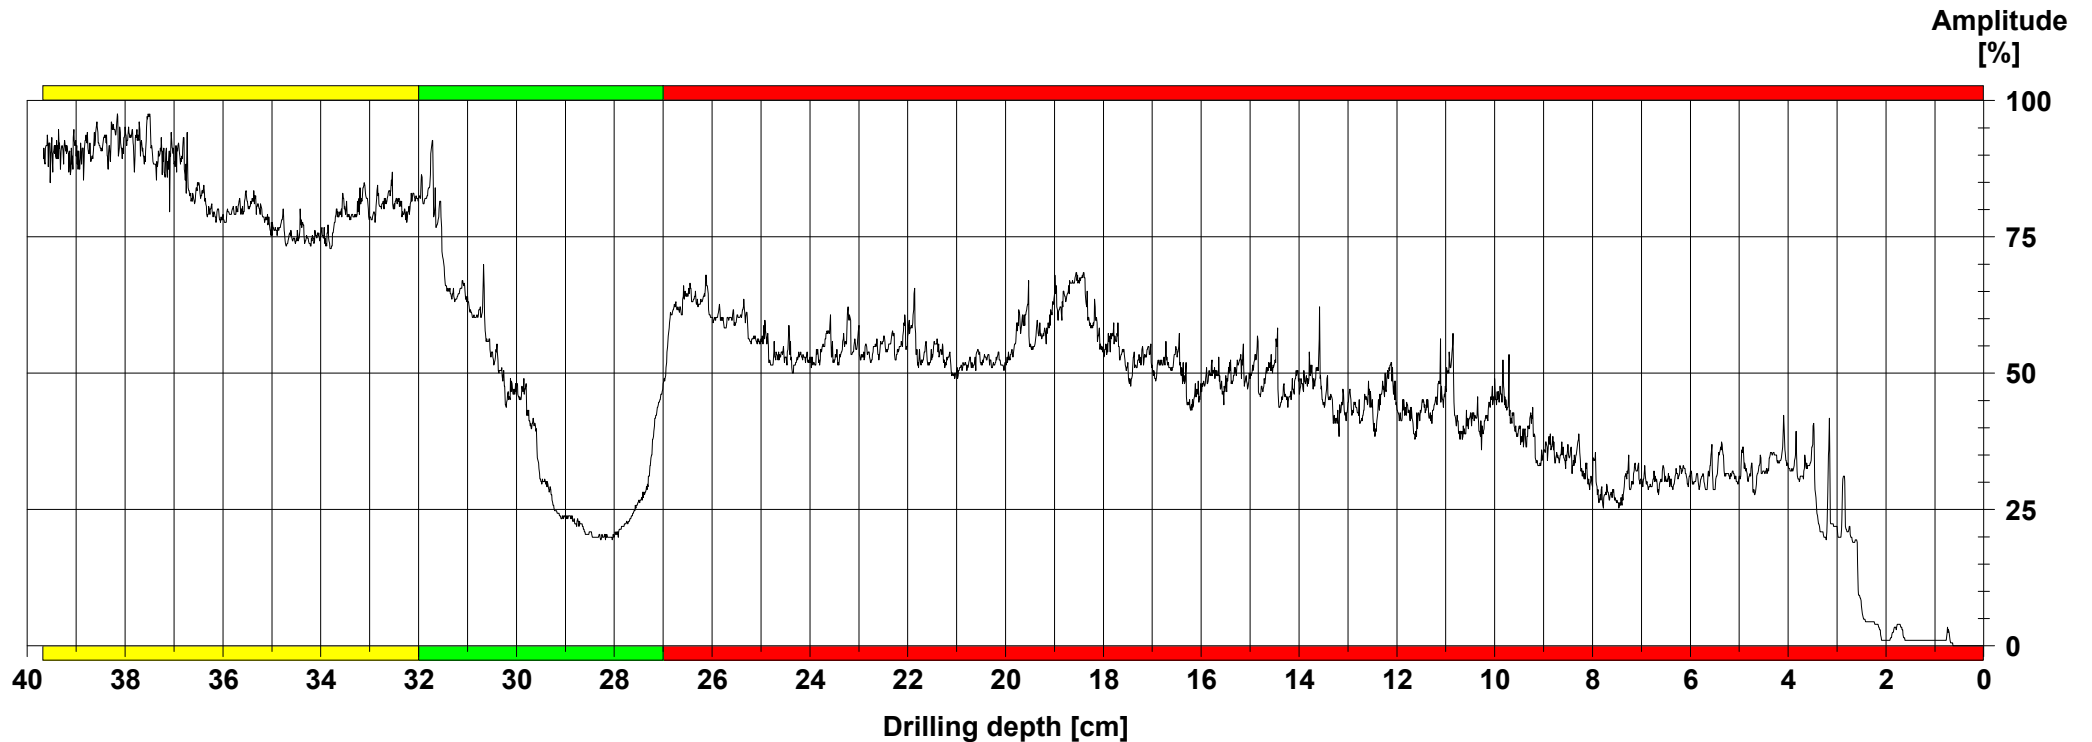
■	From 0,0 cm to 27,0 cm : Normal
■	From 27,0 cm to 32,0 cm : Small cavity
■	From 32,0 cm to 39,7 cm : Normal
■	From 0,0 cm to 0,0 cm :
■	From 0,0 cm to 0,0 cm :
■	From 0,0 cm to 0,0 cm :

There is a small amount of dysfunctional wood although at this stage it does not compromise the integrity of the tree.

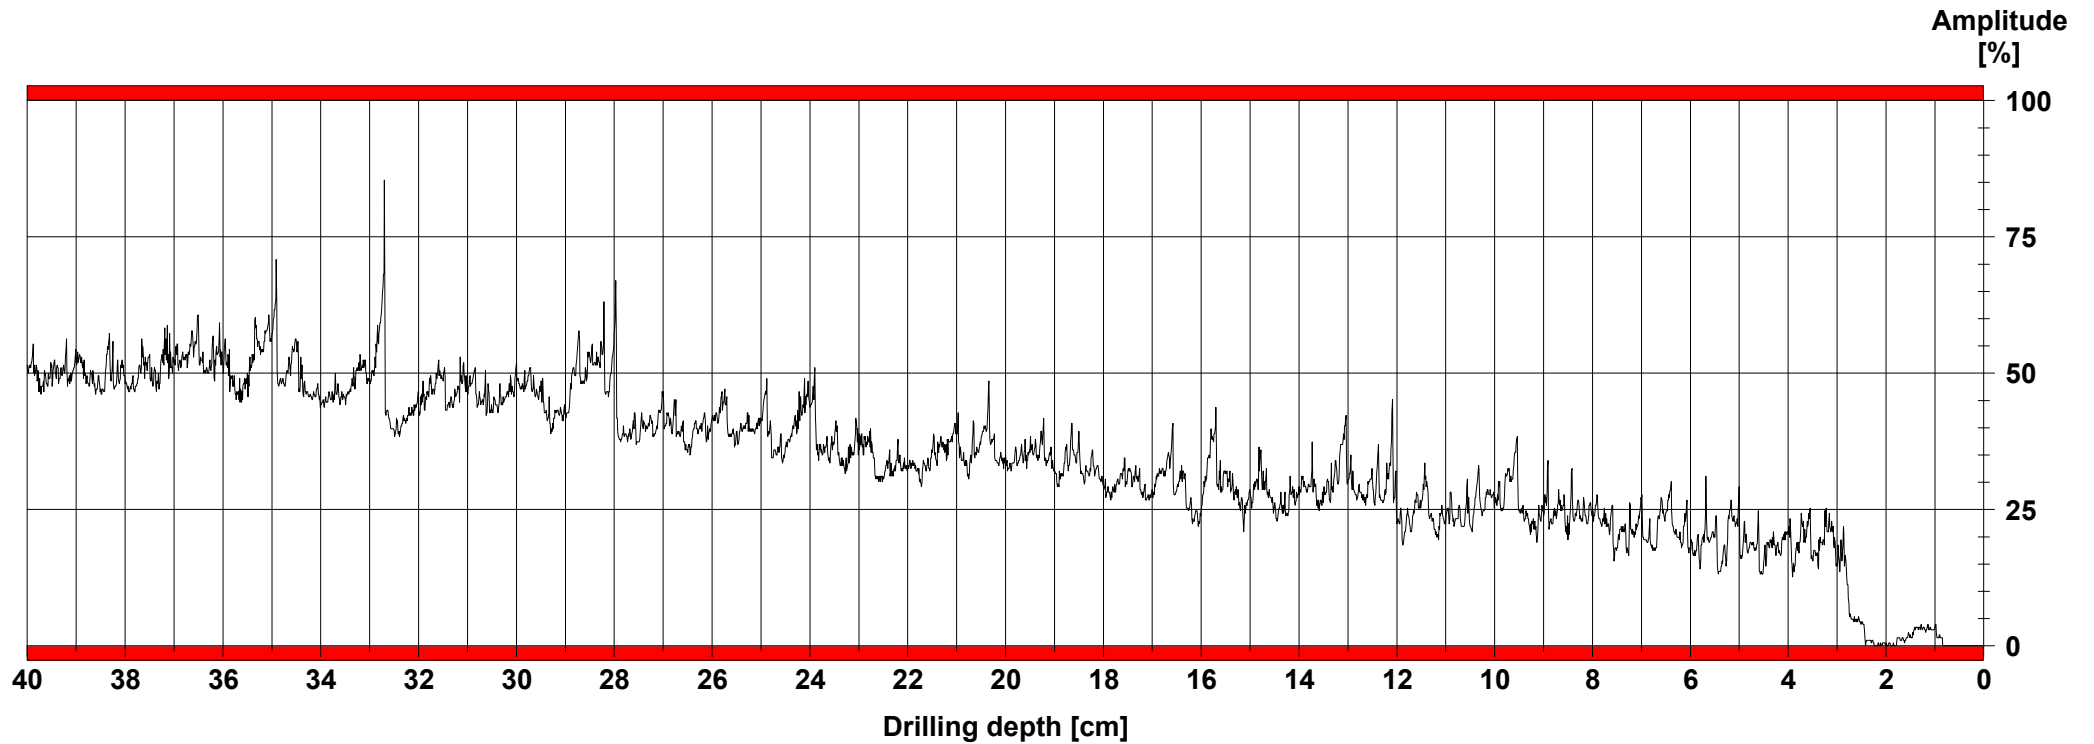
■	From 0,0 cm to 40,1 cm : No evidence of decay
□	From 0,0 cm to 0,0 cm :
□	From 0,0 cm to 0,0 cm :
□	From 0,0 cm to 0,0 cm :
□	From 0,0 cm to 0,0 cm :
□	From 0,0 cm to 0,0 cm :

No evidence of decay

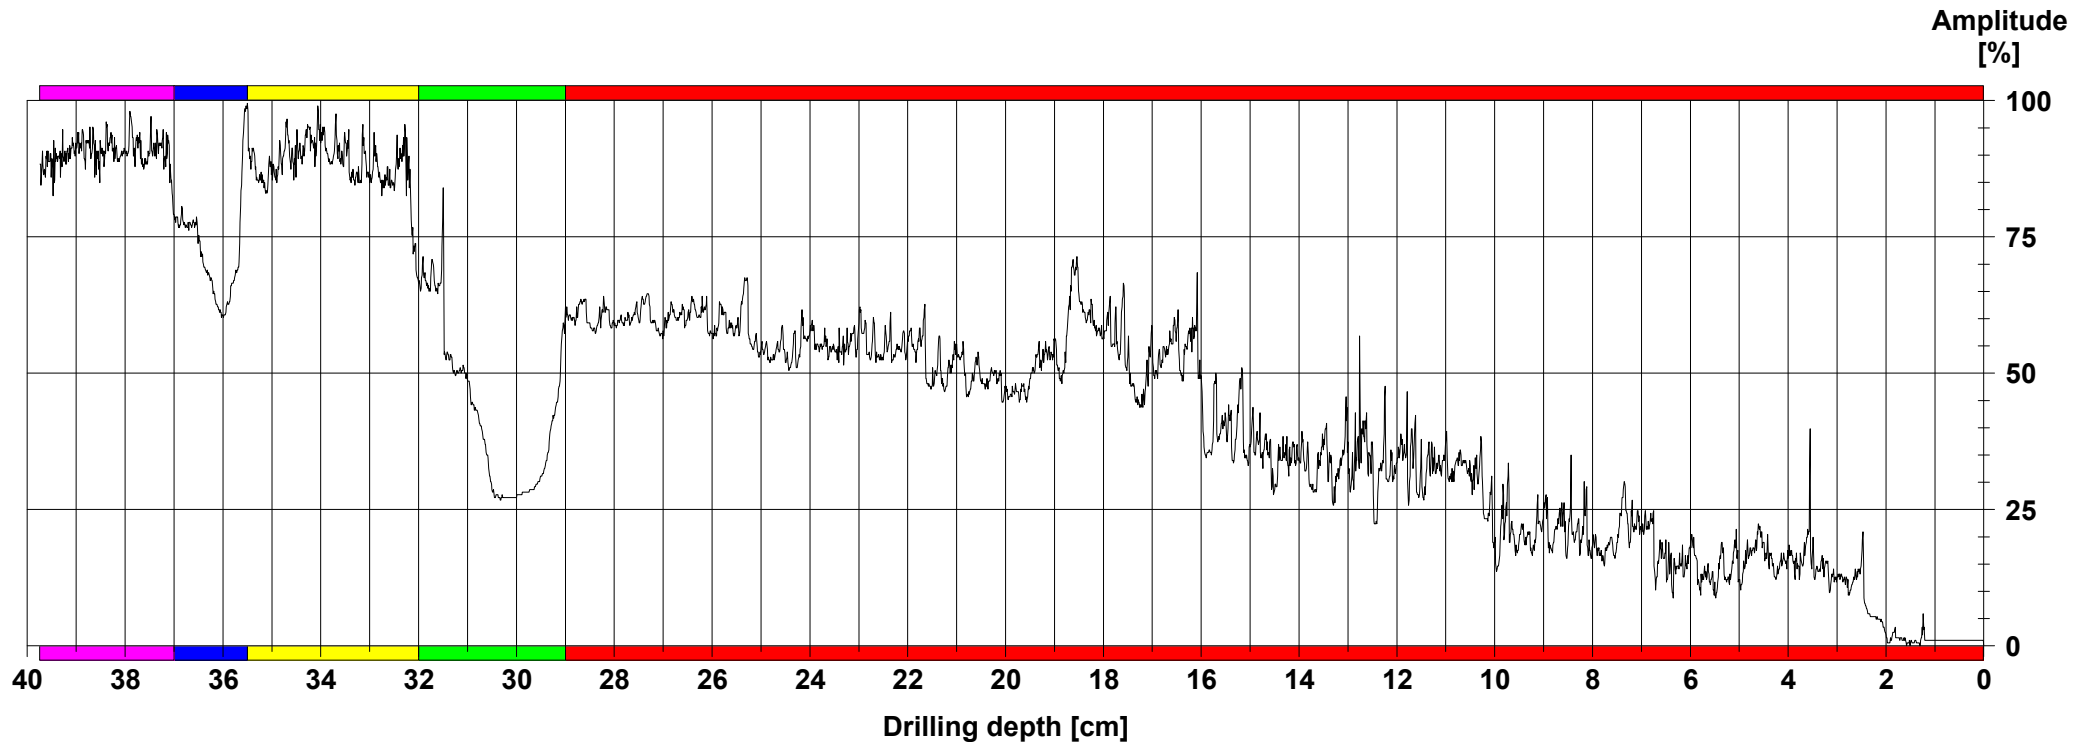
■	From 0,0 cm to 29,0 cm : Normal
■	From 29,0 cm to 32,0 cm : Dysfunctional wood
■	From 32,0 cm to 35,5 cm : Normal
■	From 35,5 cm to 37,0 cm : Dysfunctional wood
■	From 37,0 cm to 39,8 cm : Normal
■	From 0,0 cm to 0,0 cm :

There are small areas of dysfunctional wood but at this stage they are not large enough to significantly compromise the structural integrity of the tree. Ongoing monitoring is recommended.

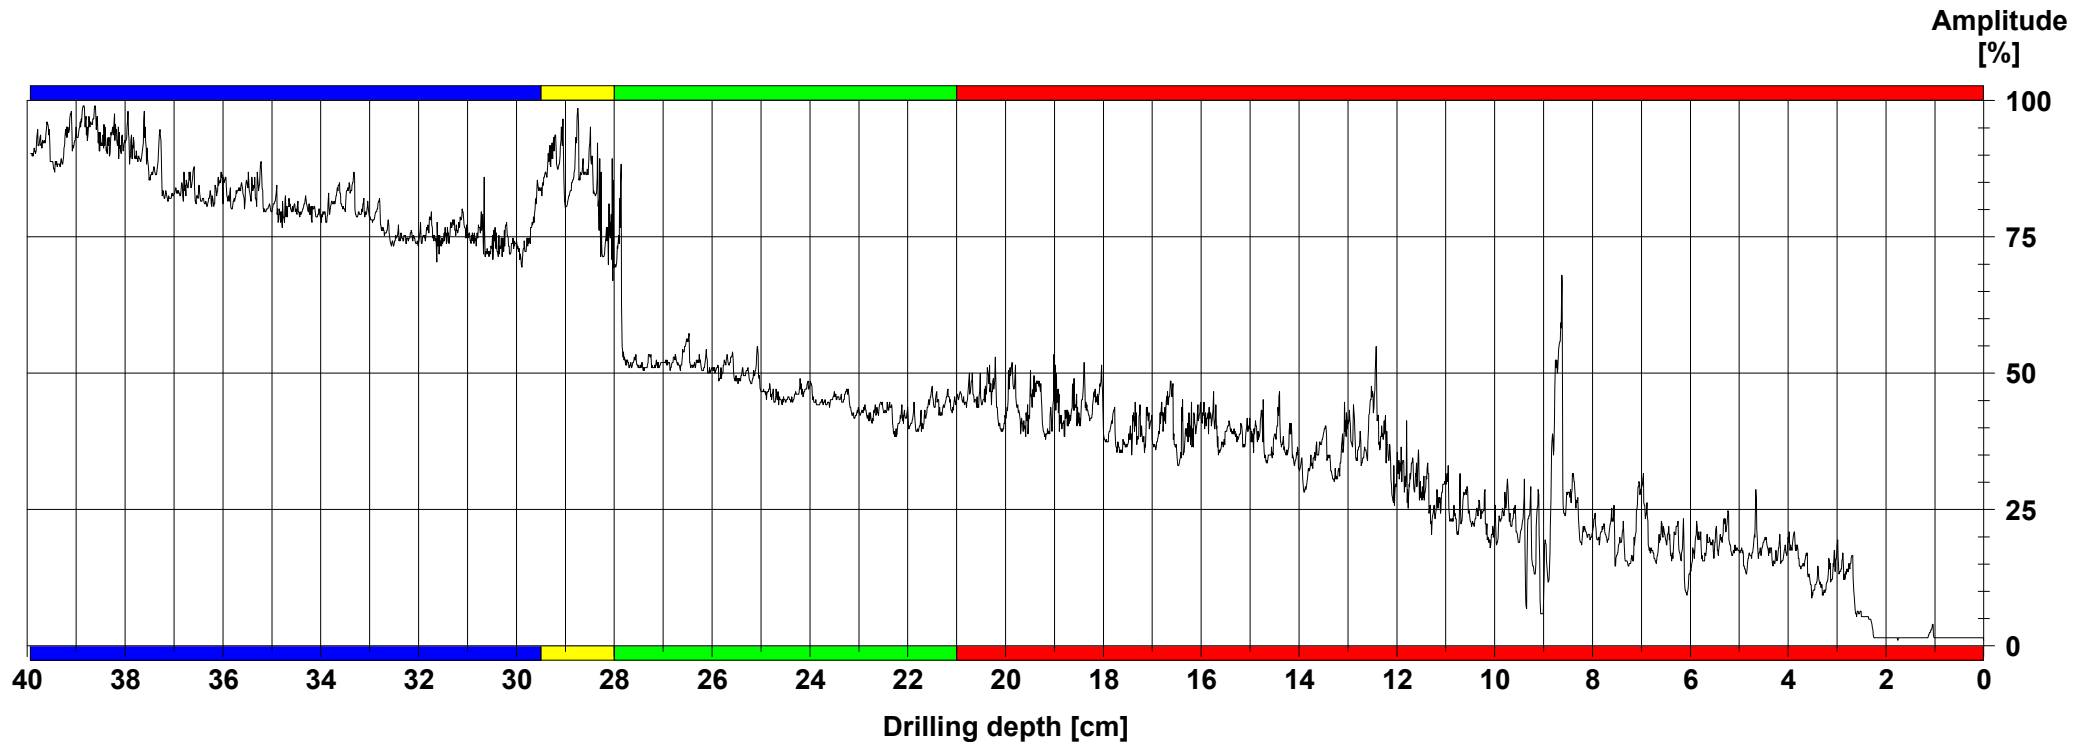
■	From 0,0 cm to 21,0 cm : Normal
■	From 21,0 cm to 28,0 cm : Dysfunctional wood
■	From 28,0 cm to 29,5 cm : CODIT Wall
■	From 29,5 cm to 39,9 cm : Normal
■	From 0,0 cm to 0,0 cm :
■	From 0,0 cm to 0,0 cm :

There is evidence of decay from 21 to 28cm however this does appear to be compartmentalised. Ongoing monitoring is suggested.

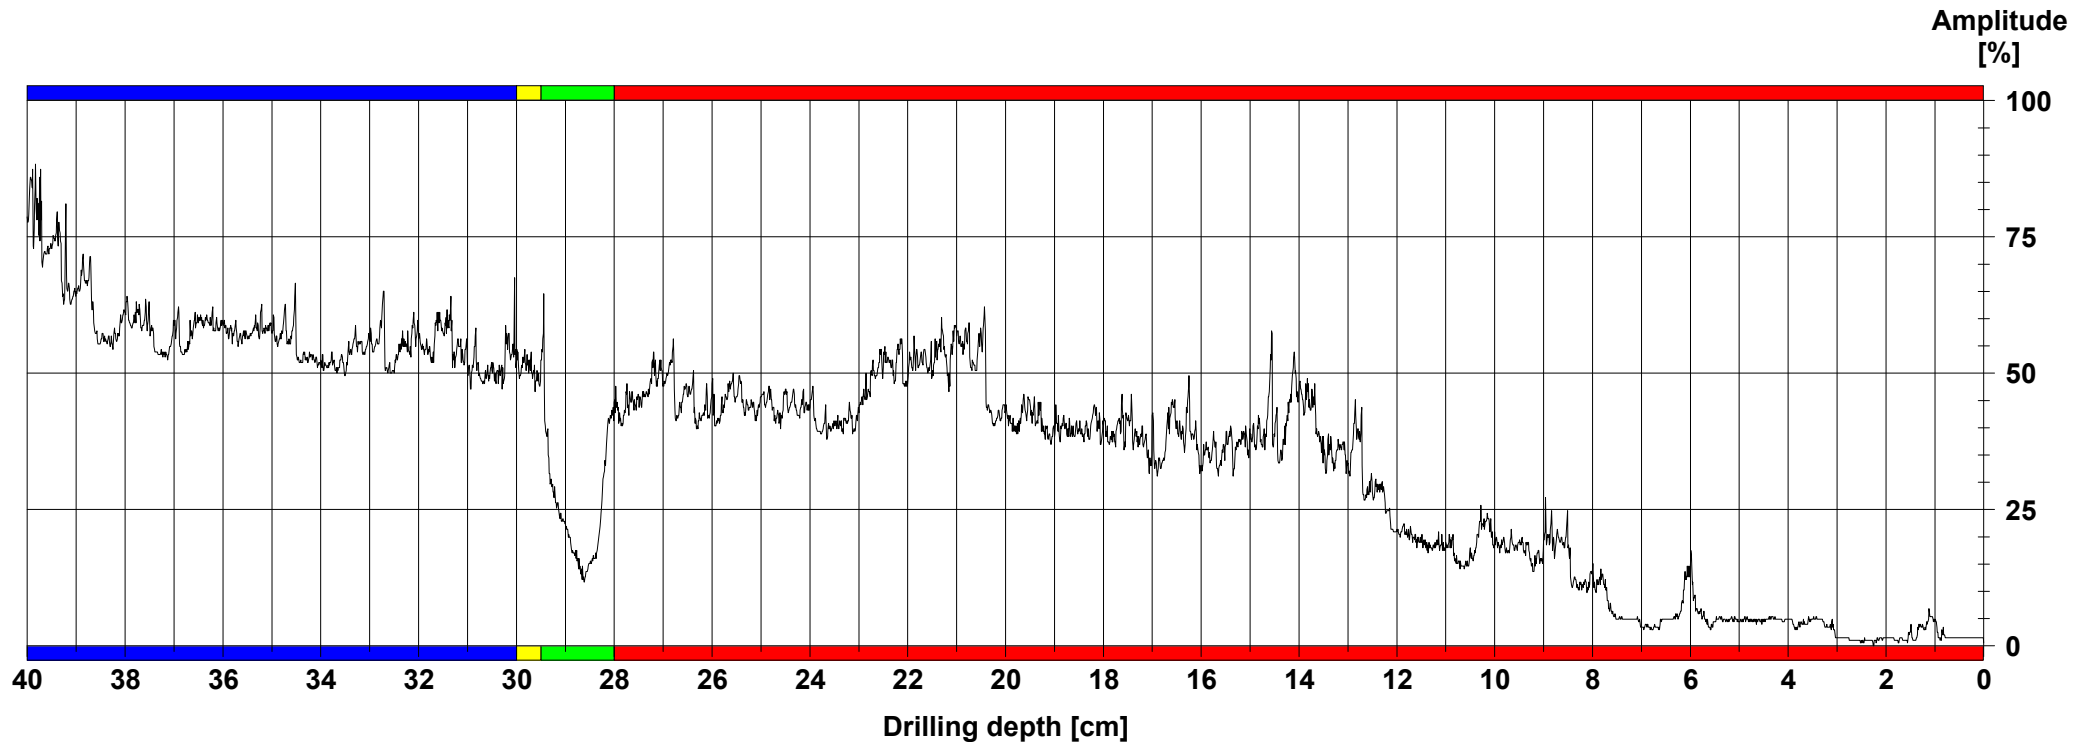
■	From 0,0 cm to 28,0 cm : Normal
■	From 28,0 cm to 29,5 cm : Dysfunctional wood
■	From 29,5 cm to 30,0 cm : CODIT Wall
■	From 30,0 cm to 40,1 cm : Normal
■	From 0,0 cm to 0,0 cm :
■	From 0,0 cm to 0,0 cm :

This tangential drilling confirms the first drilling in that there is a small area of dysfunctiona wood in the centre of the tree and that it appears to be compartmentalised. The extent of dysfunctional wood does not compromise structural integrity.

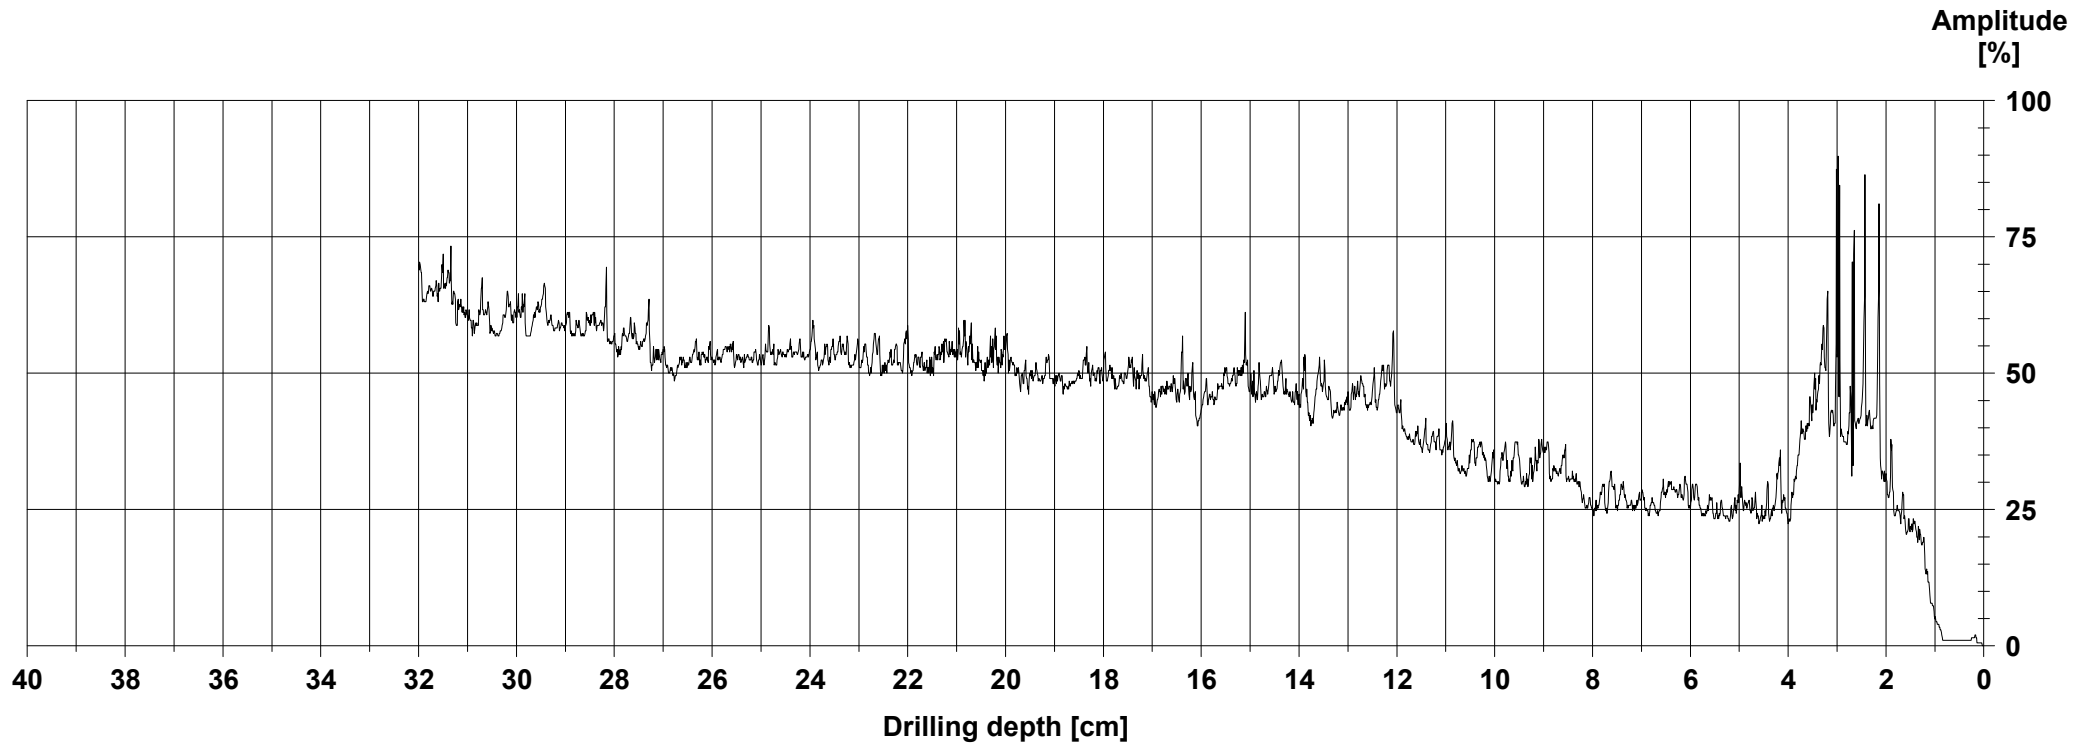
There is no evidence to show that structural integrity has been compromised

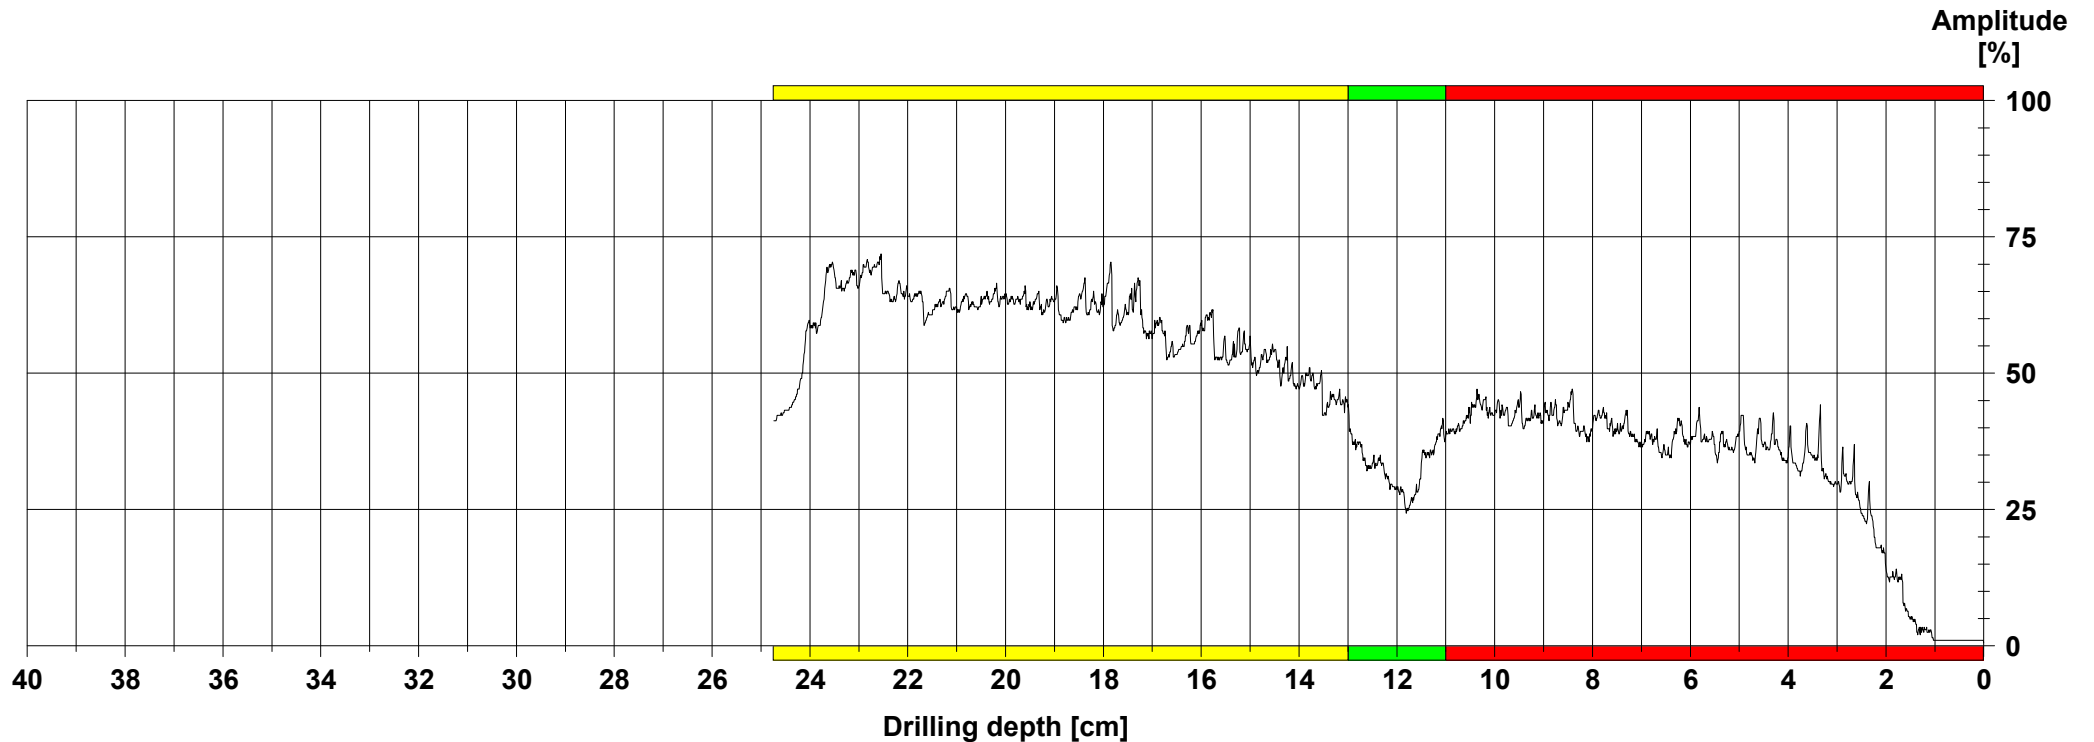
■	From 0,0 cm to 11,0 cm : Normal
■	From 11,0 cm to 13,0 cm : Dysfunctional wood
■	From 13,0 cm to 24,8 cm : Normal
■	From 0,0 cm to 0,0 cm :
■	From 0,0 cm to 0,0 cm :
■	From 0,0 cm to 0,0 cm :

There is small amount of dysfunctional wood at the centre of the tree however this is not enough to compromise the structural integrity of the tree.
