Appendix 3

Resistograph Readings

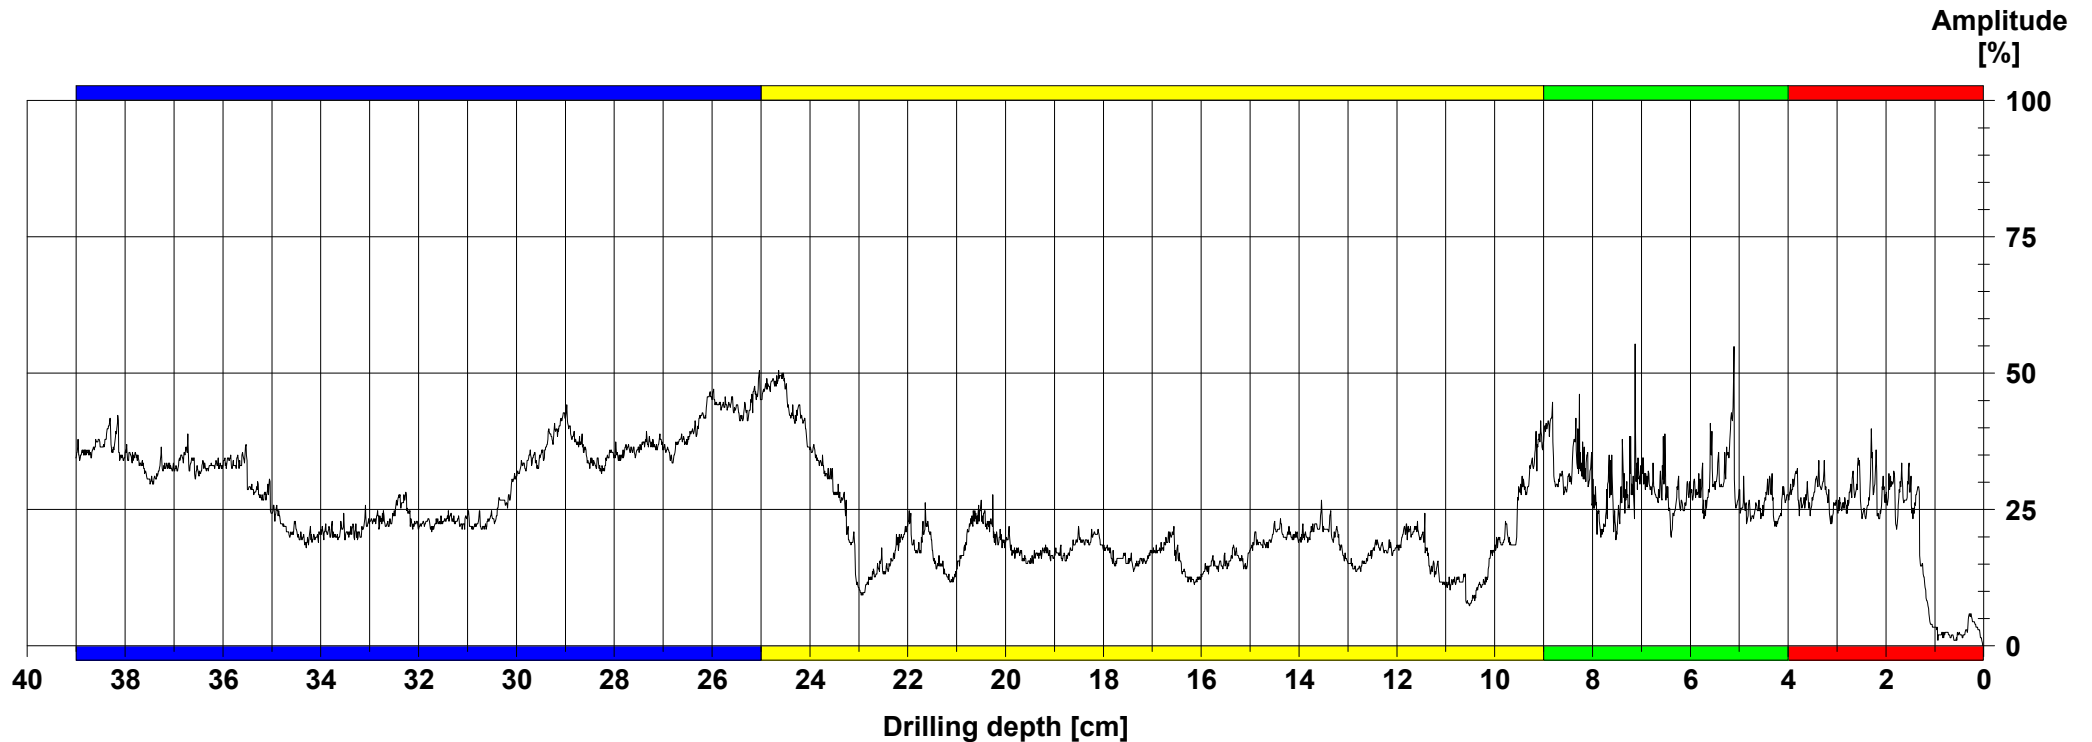
■	From	0,0 cm	to	4,0 cm	: Normal
■	From	4,0 cm	to	9,0 cm	: Possible CODIT Wall
■	From	9,0 cm	to	25,0 cm	: Dysfunctional
■	From	25,0 cm	to	39,0 cm	: Dysfunctional
■	From	0,0 cm	to	0,0 cm	:
■	From	0,0 cm	to	0,0 cm	:

Drilled through buttress root. Shows significant amount of dysfunctiona wood (in excess of 33%). Suspected influence of meripilus. Tree removal is recommended.

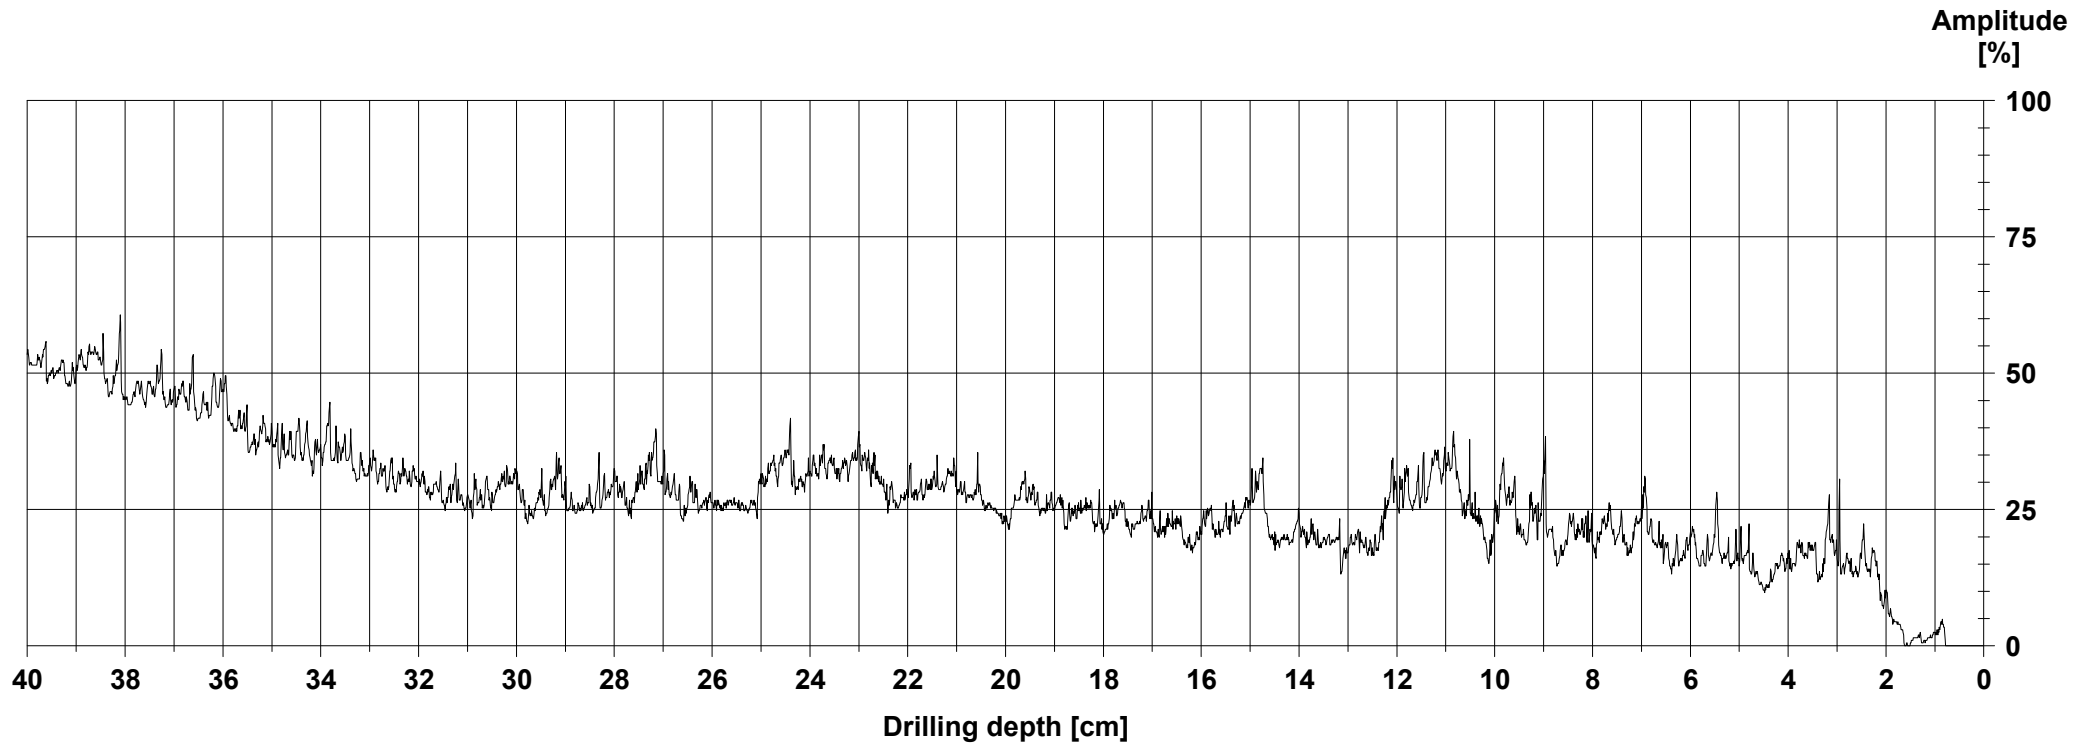
There is no evidence to suggest that structural integrity has been compromised.

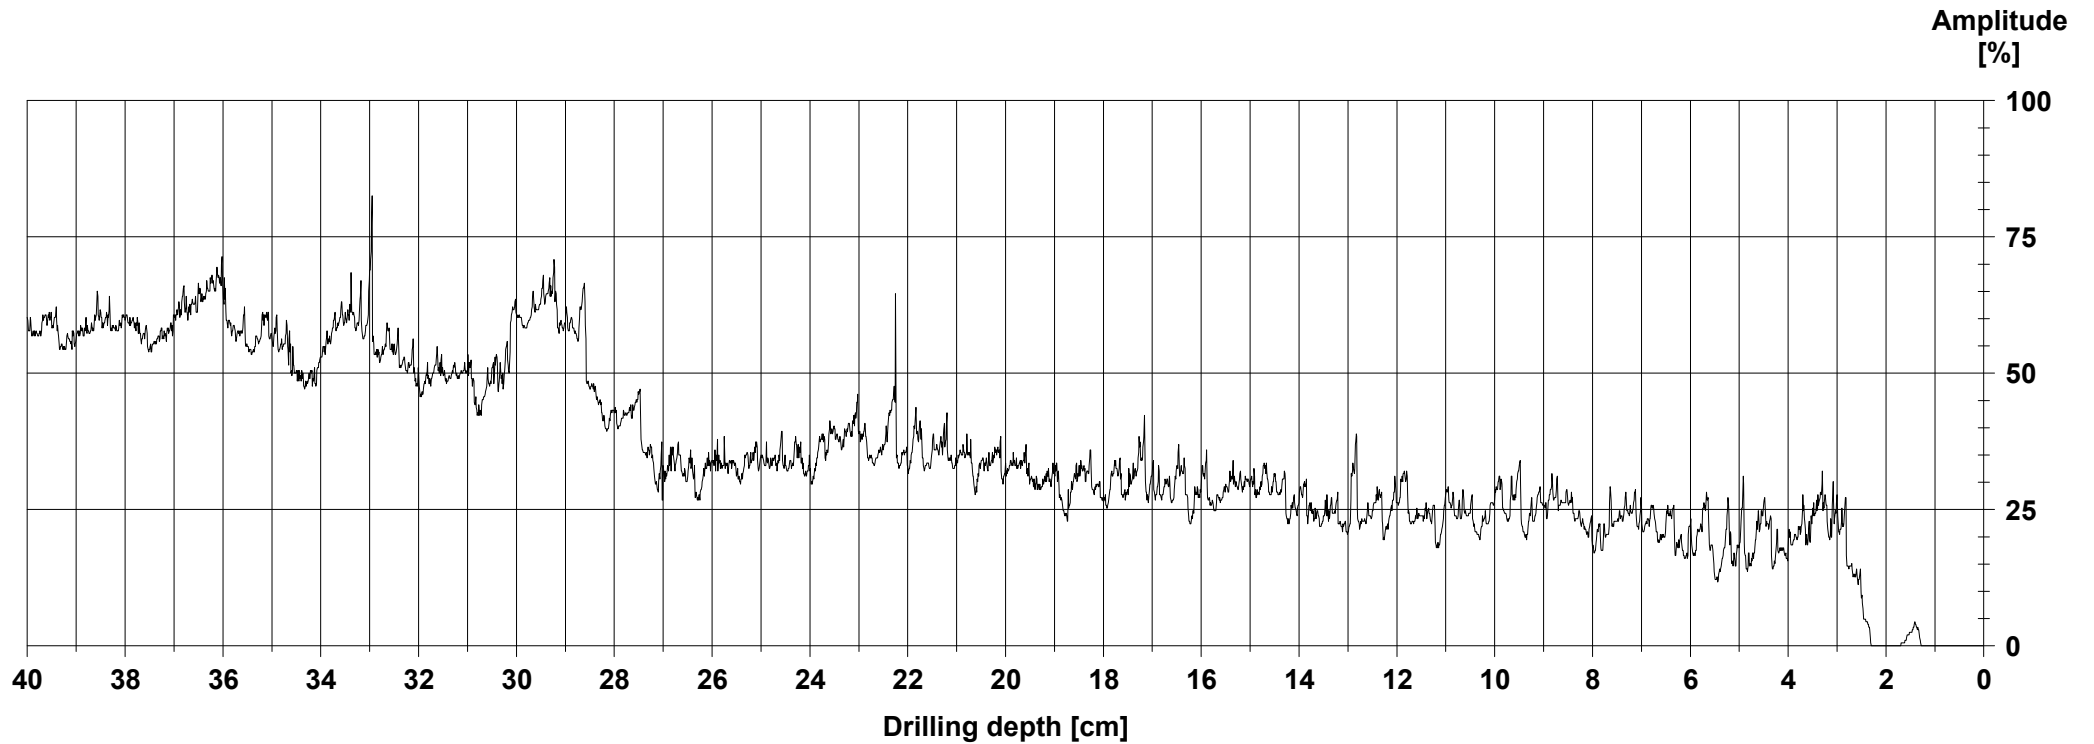
There is no evidence to suggest that structural integrity has been compromised.

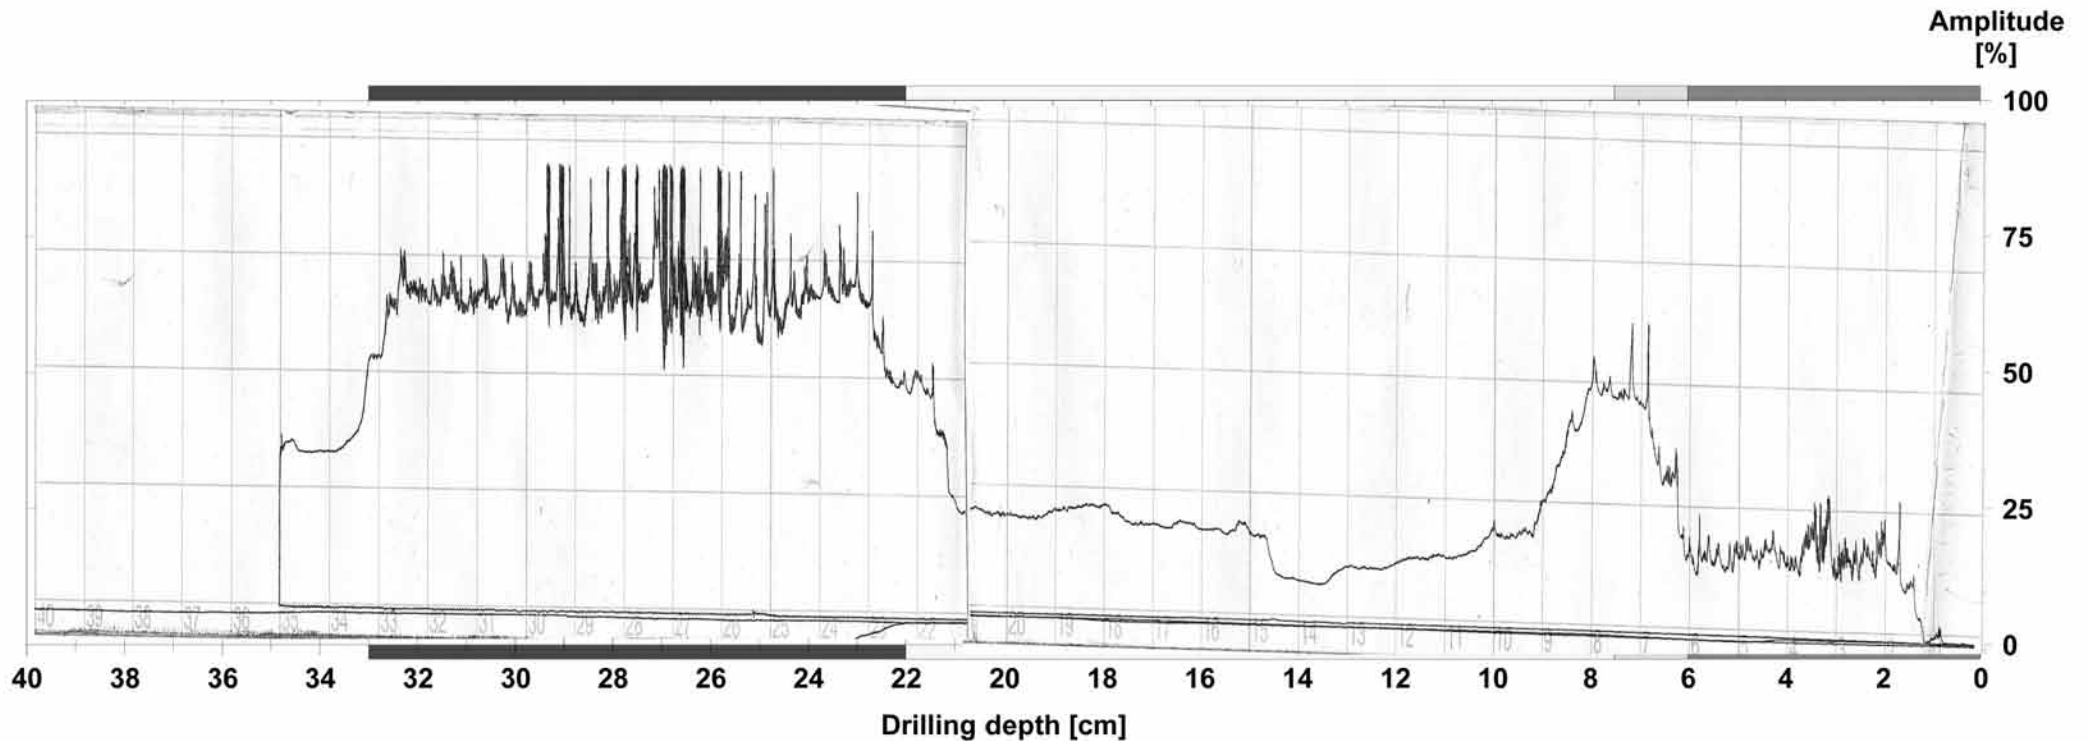
■	From	0,0 cm	to	6,0 cm	: Normal
■	From	6,0 cm	to	7,5 cm	: CODIT Wall
□	From	7,5 cm	to	22,0 cm	: Cavity
■	From	22,0 cm	to	33,0 cm	: Normal Reaction Wood
□	From	0,0 cm	to	0,0 cm	:
□	From	0,0 cm	to	0,0 cm	:

The extent of dysfunctional wood compromises the structural integrity of the limb. Accordingly it should be removed.

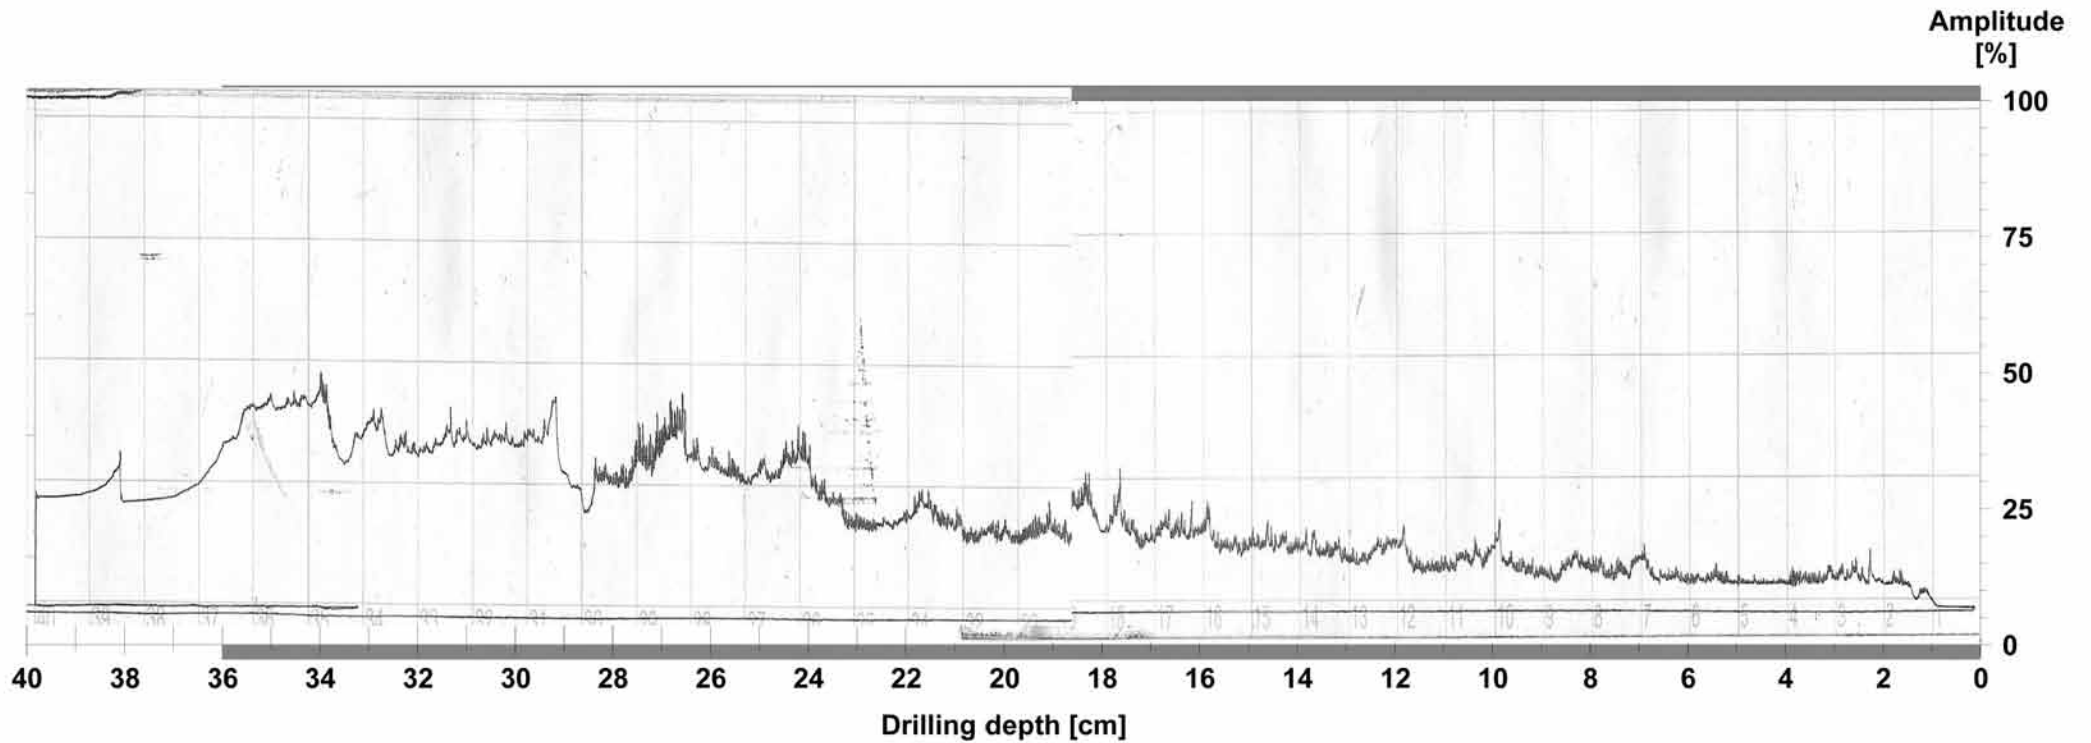
■	From 0,0 cm to 36,0 cm : Normal
□	From 0,0 cm to 0,0 cm :
□	From 0,0 cm to 0,0 cm :
□	From 0,0 cm to 0,0 cm :
□	From 0,0 cm to 0,0 cm :
□	From 0,0 cm to 0,0 cm :

There is no evidence that structural integrity has been compromised.
